Replace shearpin MullToa 55ai och 65ai

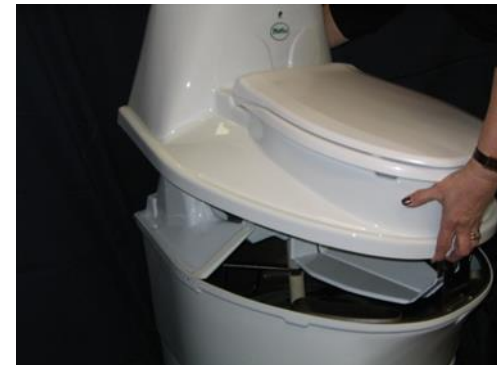
3. Remove the top

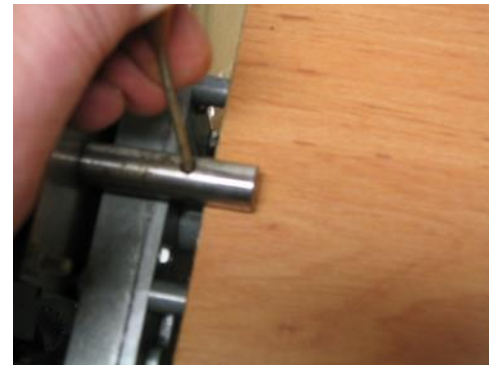
9. Remove the rest of the old shear pin, use a hammer and make sure that the axle have a solid ground when you work.

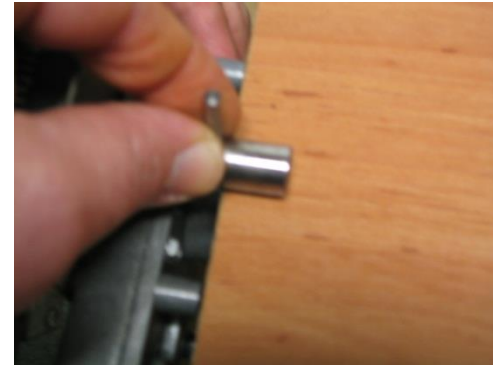
10. Put in a new shear pin. Hit the pin through and make sure that its equally on each side of the axle
- 11 Put the motor back and make sure that the bottom rake have correct position before mounting the motor..
12. Put back the cable to the pcb. Make sure that it is sitting correctly in the holder.
13. Put together the quickconnector for power
14. Put the top part back
